6 National Dam Safety Program, Pinchot Lake Dam (Inventory Number NDS 335), Susquehanna River Basin, Beaver Creek, York County, Pennsylvania. Phase I Inspection Report.

PHASE I INSPECTION REPORT

Name of Dam: PINCHOT LAKE DAM
State Located: PENNSYLVANIA
County Located: YORK
Stream: BEAVER CREEK
Date of Inspection: April 12, 1978

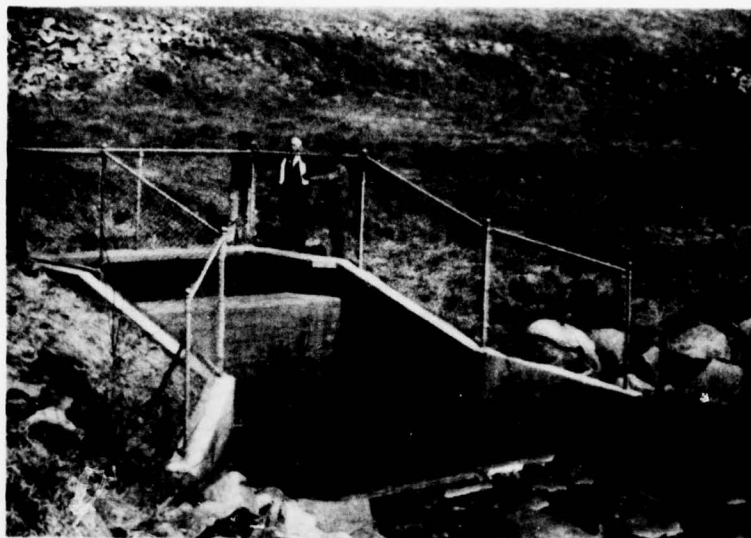
The tower appeared in good condition. The gate is operated quite regularly to prevent flooding of the beaches by keeping the pool level at elevation 470.0. The operation of the gate is difficult, probably caused by undersizing the gate hoist. The outlet of the conduit is in good condition.

Conduit
Outlet

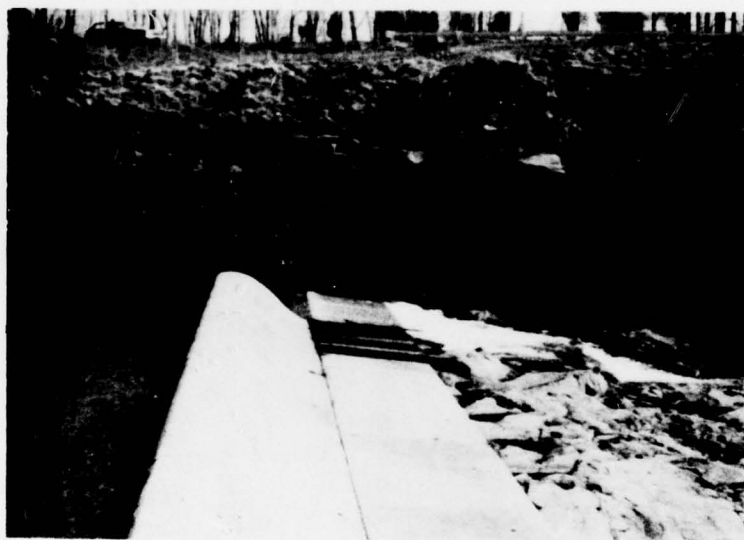
The spillway crest is in good condition. Some of the joints cause a maintenance problem due to loosening of the sealer. One vertical joint indicated some seepage.

Visual observations indicated no stability or stress problems in any of the concrete structures. Possible seepage through one of the joints in the ogee section should be observed for possible frost damage.

Notched Spillway
Ogee Weir

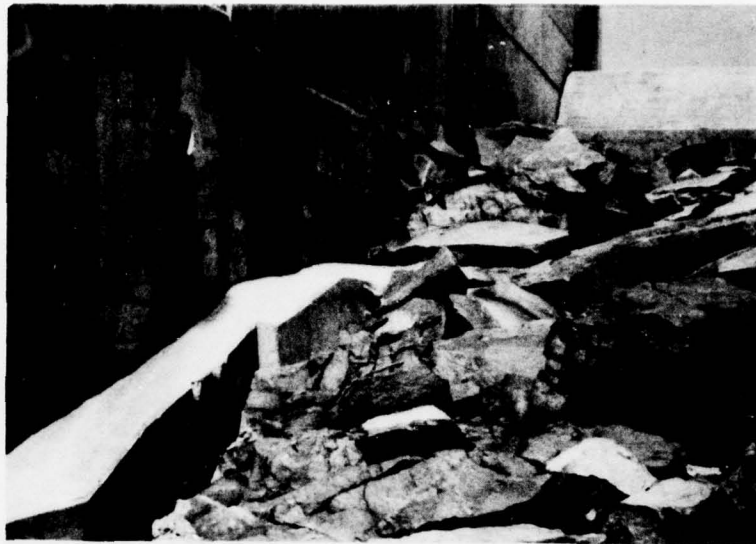
The only modifications made after construction was the installation of a concrete protection for the right wall of the spillway chute. The use of a sharp transition facing upstream in these walls is not desirable (Appendix D, Plate V). However, no damage was detected.

The right wall is of reinforced concrete set on a rock foundation. Some deep scour occurred during heavy discharges and additional concrete protection was placed along the toe of the wall. The appearance was good and no signs of distress were noticed. The stilling basin was in good condition, except for some erosion occurring at the left side of the outlet channel.

Spillway Chute
Wall Toe
Protection

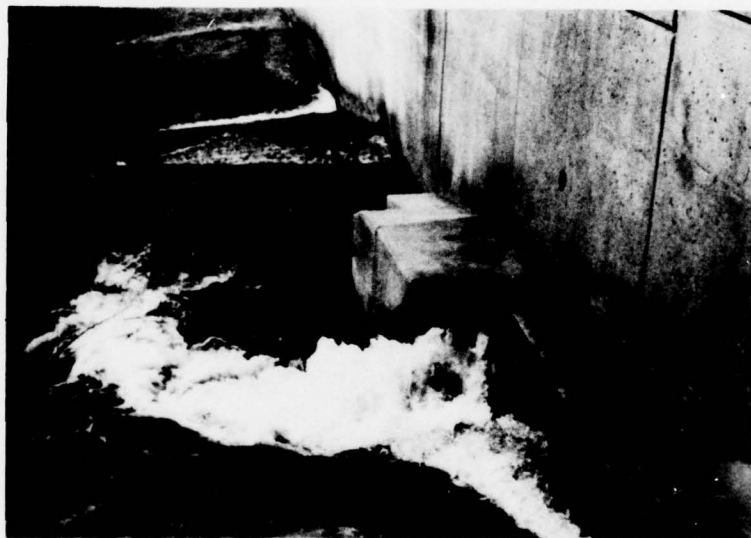
The spillway channel floor and left side are unpaved bedrock. Some erosion of the fractured rock is occurring and this requires cleaning of the stilling basin at certain intervals.

A review of the design drawings indicate that all structures are founded on rock. The type of construction and the size of footings are considered adequate and based on good engineering practice. Due to the nature of the chute (exposed rock) there will be erosion of the fractured rock and a constant maintenance program is required.

Spillway Chute

1. A formal surveillance and downstream warning system should be developed to be used during periods of high precipitation.
2. A regular inspection program should be developed to inspect possible damage to the spillway chute after high discharges, particularly in the area adjacent to the right spillway chute wall.
3. The stilling basin should be cleared at regular intervals.
4. The left wingwall of the stilling basin should be protected against further erosion.

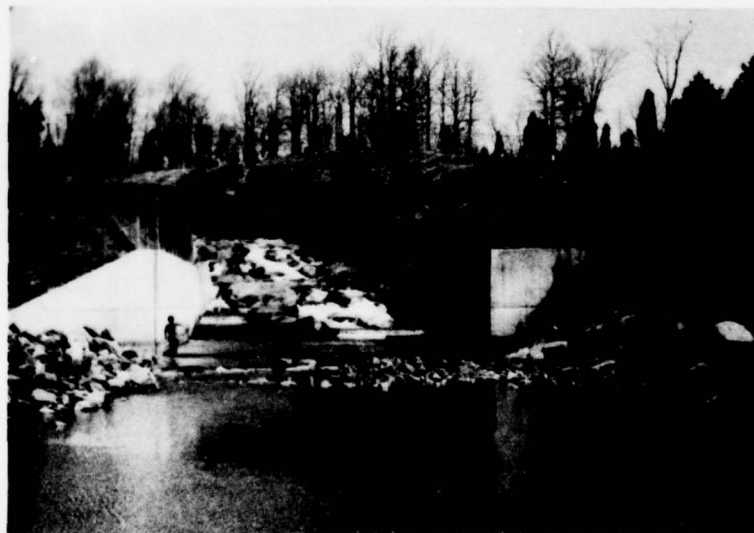
Stilling Basin

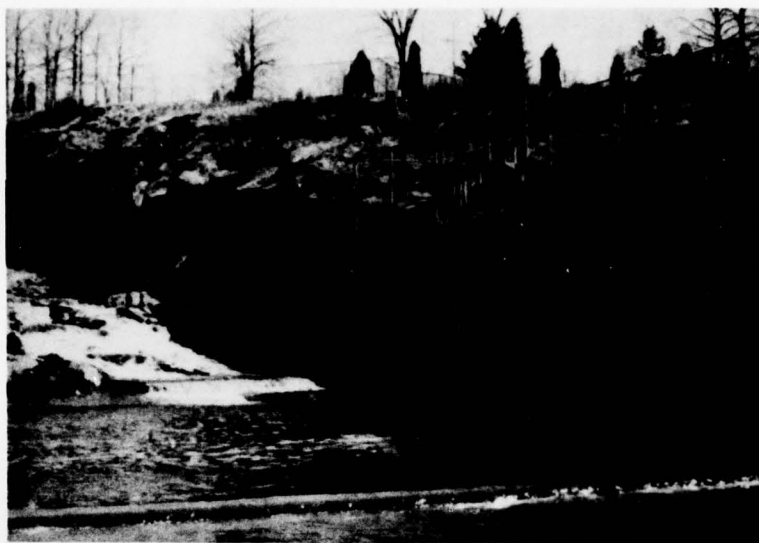
Stilling Basin

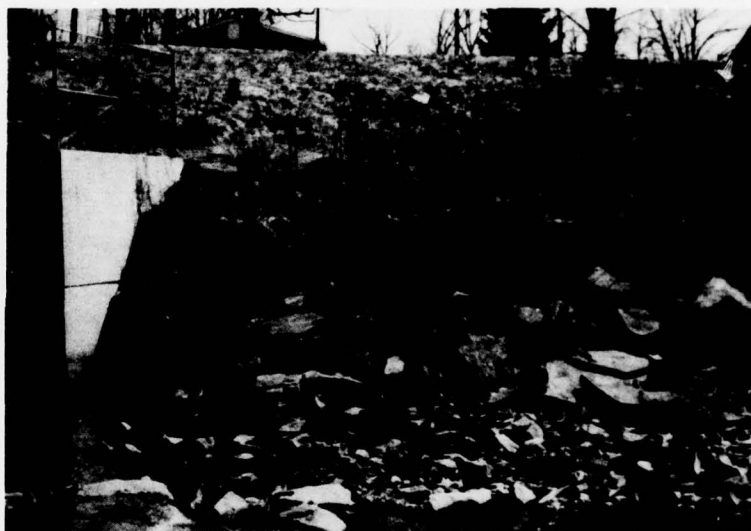
Left Wall
Stilling Basin

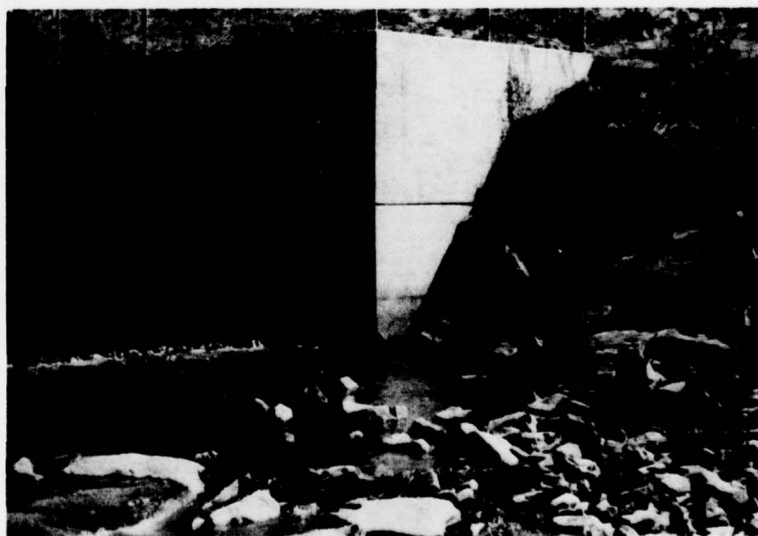
Erosion of
Left Stilling
Basin Wall
